**51st Annual Meeting of the Civil Engineering Society of Japan
(September 1996)**

Repairing of Heavily Cracked Reinforced Concrete Bridge Deck Slab From Underside

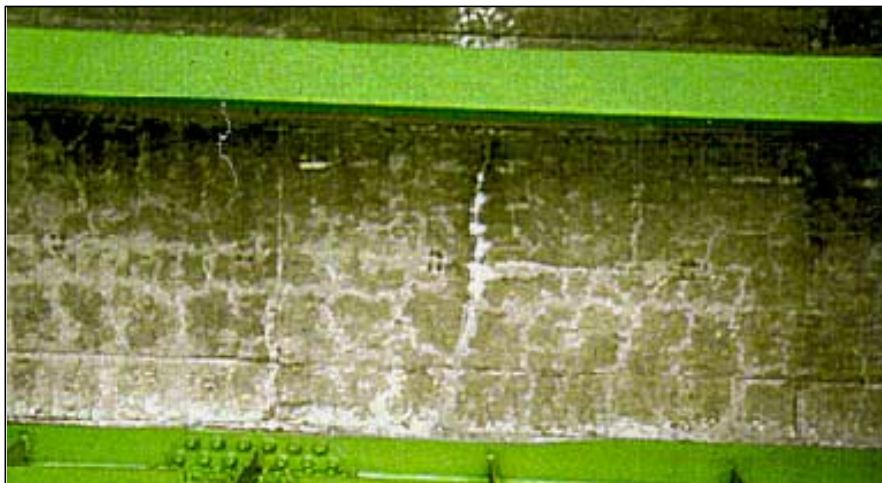
The Hokutoh overpass bridge on National Route 23 was built in 1972. There has been significant heavy traffic, with 40,000 large-size cars representing about 40% of the total traffic crossing this bridge every day. Many overloaded vehicles are also utilizing this bridge. Therefore, many cracks measuring 0.1 to 0.2 mm in width have appeared in all directions on the concrete deck slabs. Depending on the location, a significant amount of efflorescence of lime is observable and indicates water leakage. Photo 1 is an example of the cracks on the underside of the concrete deck slab.

Photo 1: Evidence of cracking in concrete on underside of the deck slab

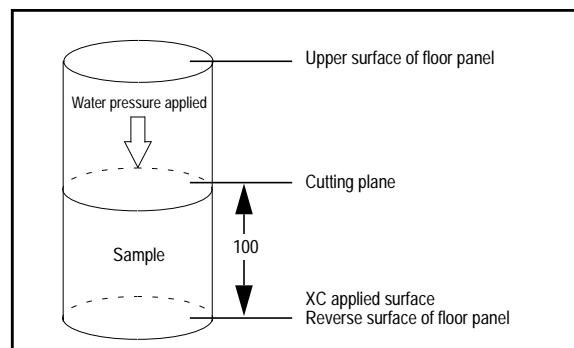
The samples for testing the water blocking ability were made by cutting the extracted cylindrical core at its half line as shown in Figure 1. The lower part of the core, where the cracks are more pronounced, was used for testing. Pressurized water was applied on the upper surface of this test specimen and water flow was recorded. See Figure 2.

Figure 1: Test sample for water blocking ability

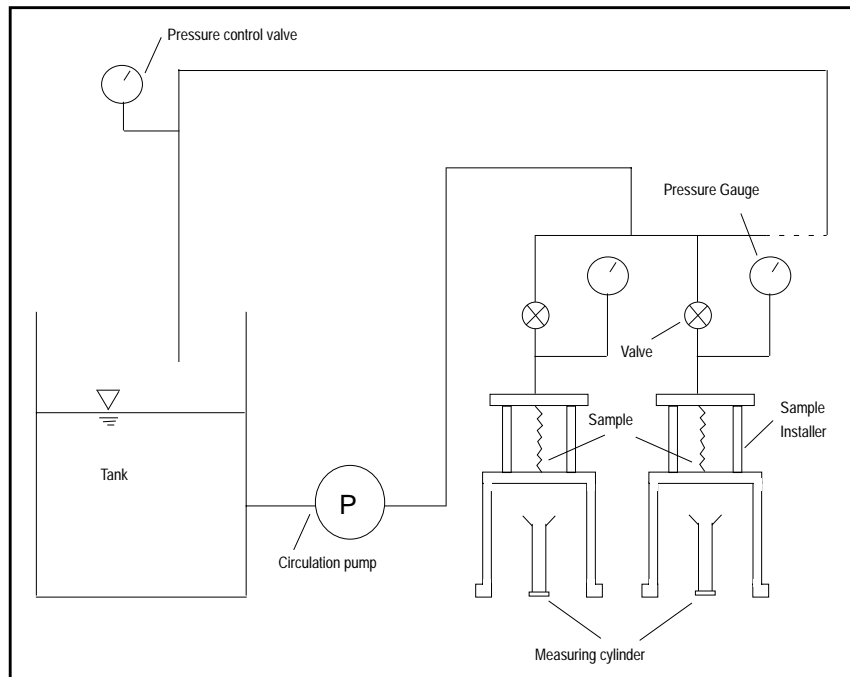
- 1) Specifications of the test:
 1. Water leak test: "Output method"
 2. Water pressure: 2 kgf/cm²
 3. Testing time: 16 hours
 4. Number of samples tested: 6 each

Figure 2 shows the conceptual structure of the water leak test.

Figure 2: Conceptual structure of the water leak test

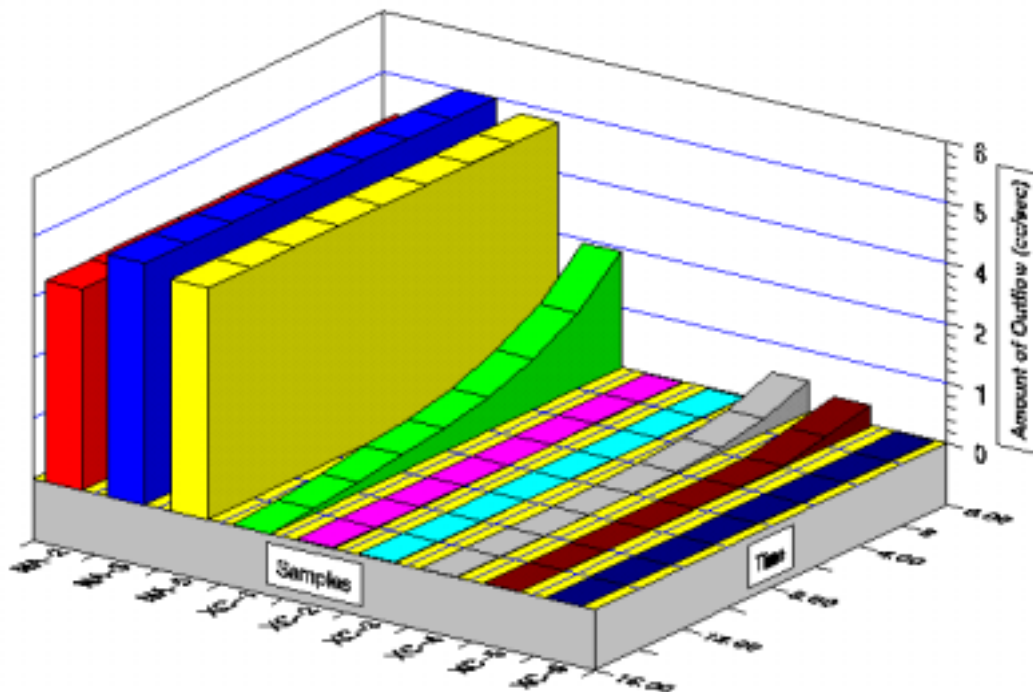
Test results shown in Table 1 and Figure 3 indicate the change in outflow from the test samples at 2 hour intervals as well as the initial amount of outflow from samples.

In the group of samples to which Xypex Concentrate was applied, there are some specimens with initial leakage but the waterflow gradually decreases and finally ceases.

In contrast, the group of untreated samples had an initial outflow reaching almost 5 cc/sec (300 cc/min) therefore it was difficult to continue the succeeding measurements. At that point, it was assumed that the amount of outflow was constant.

Figure 3: Change in Amount of Outflow with Time

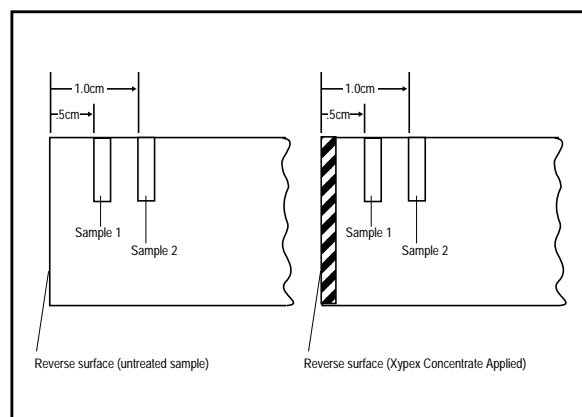
Test samples for the Scanning Electron Microscopy (SEM) were taken at locations 5 to 6 cm and 10 to 11 cm from the surface on which Xypex Concentrate was applied. See Figure 4. The width of cracks in these sub-samples were within the range of 0.08 to 0.18 mm. Structural observations were recorded.

- 1) The extraction procedure for the test specimens for SEM observation is shown in Figure 4.

Figure 4: Location for extracting the SEM observation samples.

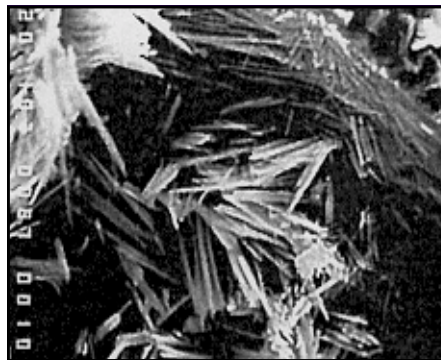
An increase of “cement” crystals can be observed in the void of cracks in Xypex Concentrate treated sample (Photo 2). In the untreated sample (Photo 3) only the gel wall can be observed. SEM photographs on these two samples had a magnification of 1000 times.

Photo 2: Xypex Concentrate Applied Sample

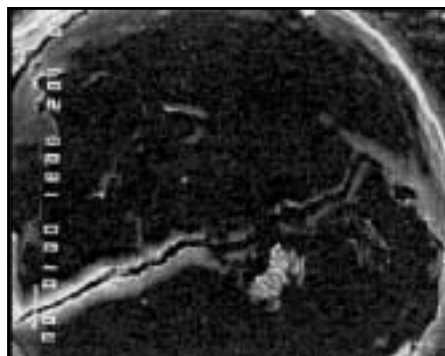
Photo 3: Untreated Sample
